Home Inspection Report

123 Nw 10th Ave Circle, John Doe, IA 50000

Wednesday March 30, 2016

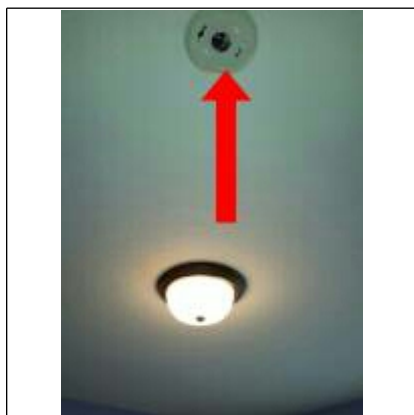
Comments Smoke detector. In the purple bedroom, SE bedroom. The smoke detector is missing in this room. Recommend a certified fire prevention technician to evaluate and repair if needed.

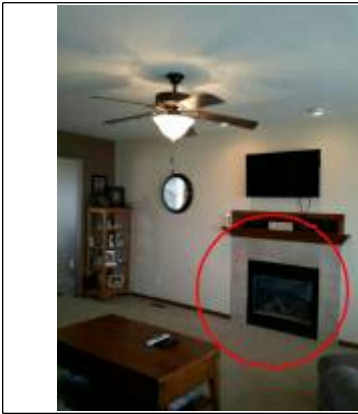
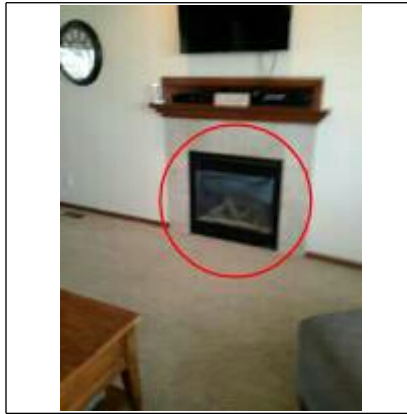
Comments Fire place. The glass on the fireplace is discolored. Unknown if the glass has failed or its just the heat has discolored the glass. Recommend having a certified fireplace technician to evaluate and repair if needed.
